Manhole Inspection Summary

Manhole # S19AA_001MH

Insp Date: **3/9/09 1:17 PM**

Location Address: **800 BRICE ST**

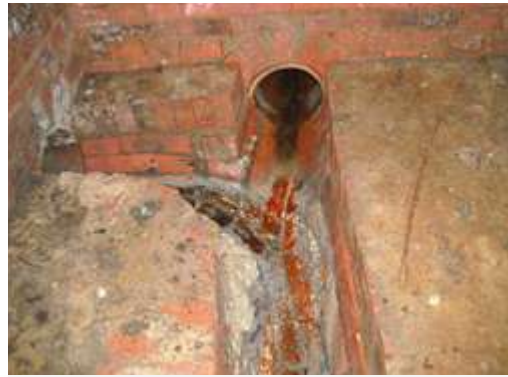
Top View

THIS JUNCTION IS OFFSET - NOT SEEN FROM TOP VIEW

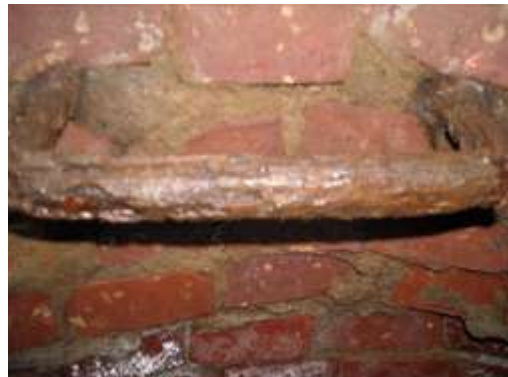
Defect 3

Count: **5** Missing: **0** ☒ **Corroded**

CORRODED STEP

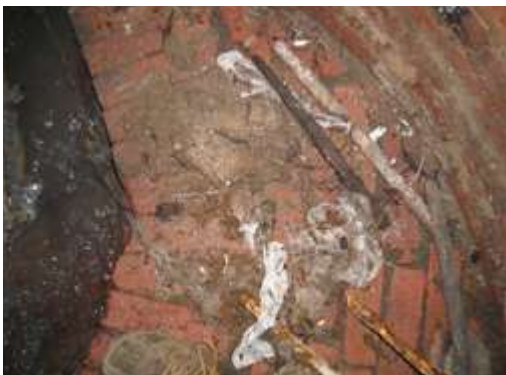
Defect 2

☒ **Evidence Of Surcharge** Depth: **1** (ft.) ☐ Active Surcharge Present

DEBRIS ON BENCH - EVIDENCE OF SURCHARGE AT 1'

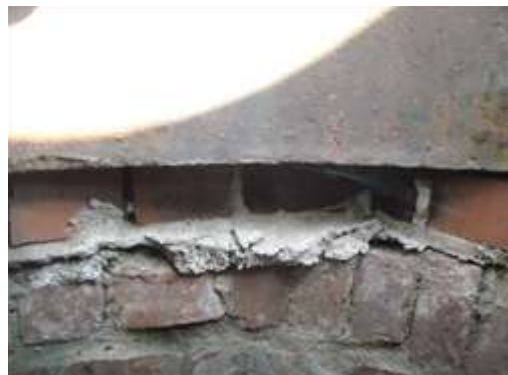
Defect 1

Condition: ☐ Sound ☐ Cracked ☐ Root Intrusion ☒ **Loose Brick** ☐ Deteriorated

LOOSE BRICKS IN CHIMNEY

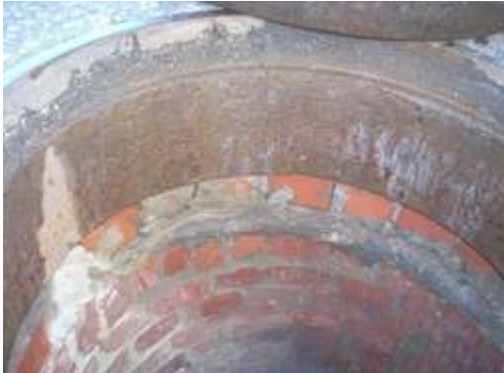
Defect 2

LOOSE CHIMNEY BRICKS

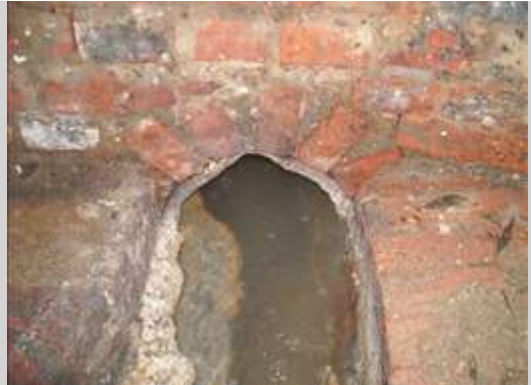
12 O'Clock Outflow

Pipe Height: **8.4** (in.) Rod and Bar (Angled)
Pipe Material: **Clay** ☐ Pipe Lined
Invert Depth: **9.51** (ft.) Flow Characteristics: **Slow**
Deposits: ☐ None ☐ Mud ☒ Sludge ☒ Debris ☐ Grease
Silt Depth: **4** (in.) Deposits Extent: **Medium**
Infiltration: **None** Pipe Seal Cond: **Sound**
